Manhole Inspection Summary

Manhole # S15QQ1009MH

Insp Date: **11/20/06 12:59 PM**

Location Address: **4918 GREENSPRING AVE**

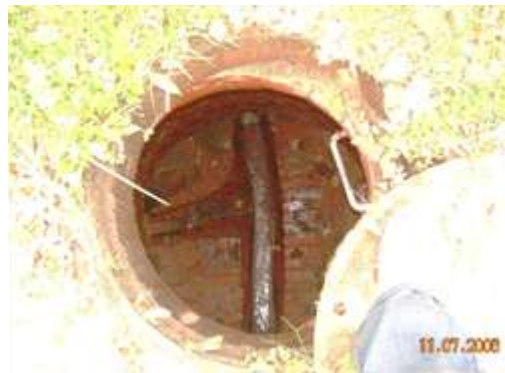
Top View

Evidence of surcharge - Bench debris. Frame leaks. Frame offset. Adjustment deterioration and infiltration.

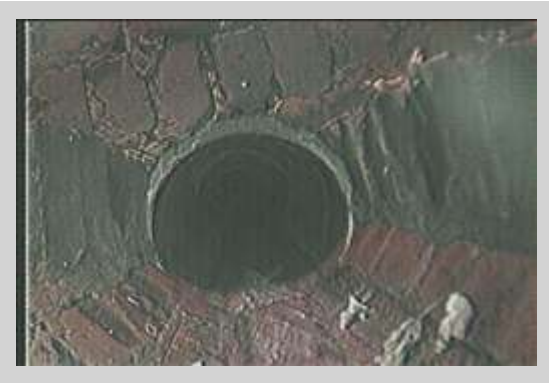
8 in. Circular Gravity Sewer Pipe Out @ 12 O'Clock

Barrel deterioration and infiltration. Channel deterioration.

Infiltration: **Evidence** Pipe Seal Cond: **Cracked**

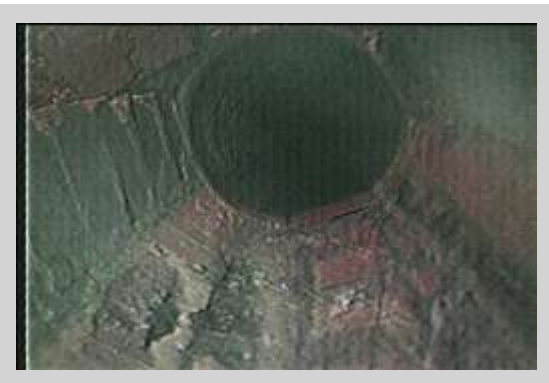
8 in. Circular Gravity Sewer Pipe In @ 6 O'Clock

Barrel deterioration and infiltration. Channel deterioration.

Infiltration: **Evidence** Pipe Seal Cond: **Cracked**

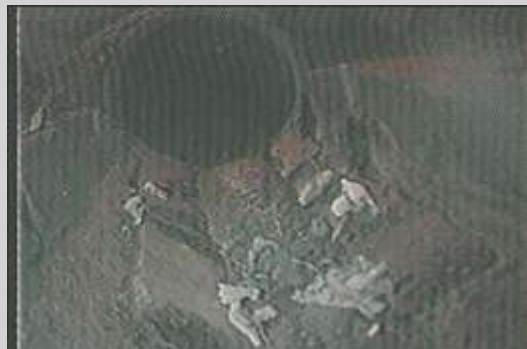
6 in. Circular Gravity Sewer

Infiltration: **Evidence**

Pipe Seal Cond: **Cracked**
